Conservation of Our Lady of Help Church, Ribandar, Goa

Abstract

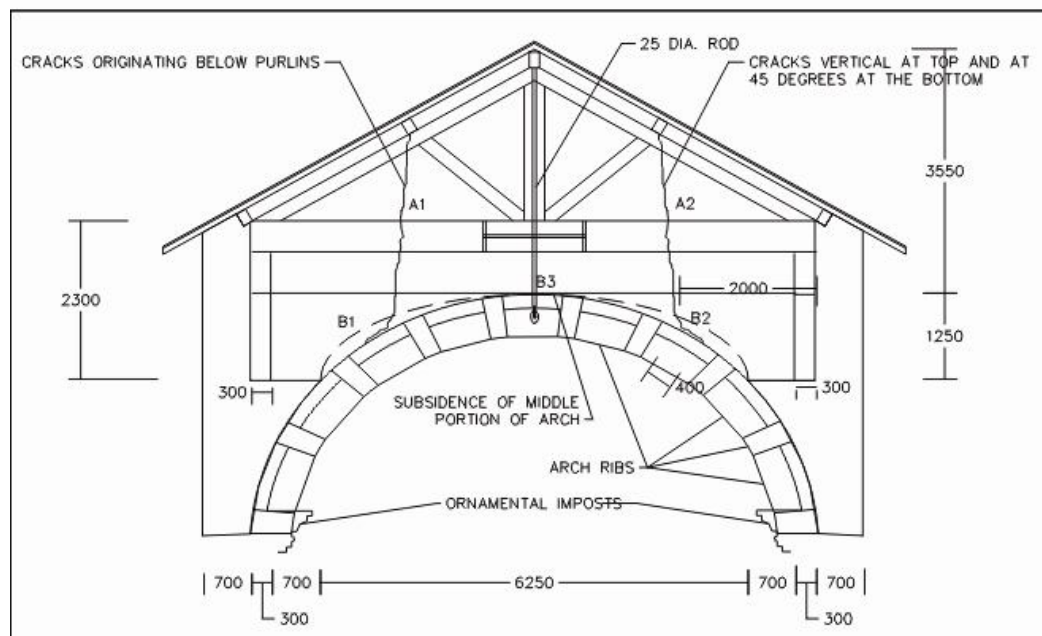
Figure 2: Elevation of rear wall (Above altar) from 25DIA ROD.

longitudinally throughout the length of the barrel arch. Also, another crack was visible on the underside of the barrel arch, at the junction of the main arch wall and the arch circumference, which is at right angles to the other two cracks thus depicting the detaching of the barrel arch from the main grand arch wall.

A1, A2: are the cracks in the Main Wall over the Main Arch.

B1, B2 and B3 are the cracks seen in the barrel arch.

B4: the separation of the grid arch from the Main wall.

B5: The slipped Voissior position.

The portion of the barrel arch from the haunches on both the sides up to the crown appeared to have sagged out. The speed breaker outside the church laid about 10 years back added to the vibrations and the sagging of the arch due to heavy traffic. One of the walls on which the arch rests, was found to be slightly out of plumb. The slight movement of the wall and the vibrations had 'relaxed' the arch resulting in the arch-intrados at the crown to open up, thereby leaving a fissure and dislocation between the lateritic stone blocks, creating 'hinge effect'. A stone from the longitudinal rib of the

grid from the barrel arch located at the crown slipped from its position and crashed on the altar below.

The barrel arch was scrapped with wire brush and the loose mortar between the laterite stones was dusted and removed. It was observed that the mortar between the stones was very loose. At some places, the mortar thus removed was so much that a hand could pass through and through and touch the wooden shuttering below. Overall, the depth of the loose mortar removed was larger than half the thickness of the barrel arch. Few laterite stones of similar character as the rest were procured from another heritage site in order to replace them with the damaged ones. The barrel arch stones were inspected for damage, crushing, loosening out. Most of the stones depicted good character and shape. Only a few stones in the barrel arch were found to be damaged and were replaced by the ones of good character and shape. The laterite stone which had slipped and fallen down on the altar below was replaced by a new one after dressing it to proper shape.

Stainless steel bars of Type SS316 were bent to the shape of a stitch. These were then used to stitch the laterite stones in the barrel arch. Mortar made-up of lime, sand and a particular fruit juice, which was normally used for structures in Goa during their construction, was mixed up to plastic consistency and placed within the crevices so created due to scrapping of mortar between the laterite stones to bind them. A screed of cement mortar was laid over the barrel arch and smooth finished in order to prevent any damage due to the leakage of water from the Mangalore tiled roof.

A steel wall plate running the full length of the wall was placed over the wall, below the purlins so as to distribute the load over a larger area. The main arch wall cracks were scrapped cleaned of debris and the cracks were filled with similar character laterite stones, with through stones at a regular spacing. The damaged stones were removed out and replaced with good ones. Similar to the process over the barrel arch, the stainless steel SS Type 316 bars stitching was carried out to the laterite stones at the cracked portion and the junction of the barrel arch and the main arch wall. Cement Grouting was carried out to the main wall and re-plastered.

In order to prevent any further lateral movement of any of the four walls supporting the arch, a bracing of tubular rectangular hollow steel sections was

fabricated and placed over the top of the barrel arch connecting the four walls rigidly to one another. The pulley bar was secured to this bracing to relieve the barrel arch crown.
