The Mobile Crane-Related Industrial Accident Caused by the Failures of Bolts

Abstract

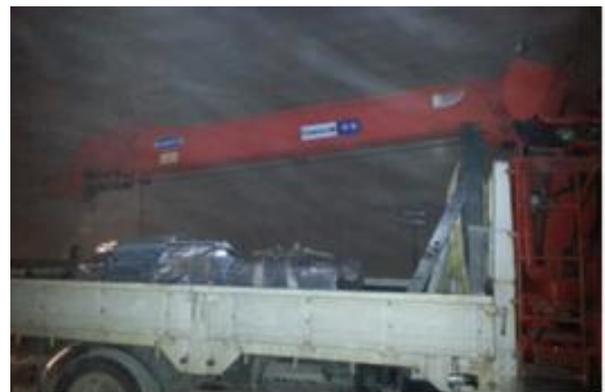
Figure 1: The mobile crane (cargo crane truck) used

Figures 1 and 2 show the mobile crane used at the time of the accident and the work of attaching some steel parts in the tunnel. Then, Figures 3, 4 and 5 show the bucket-type work

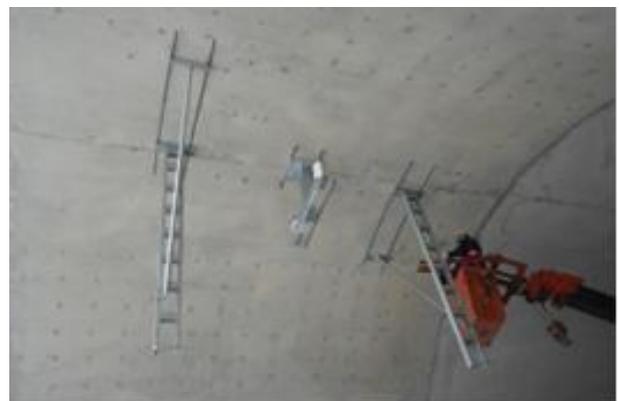
Figure 2: The work of attaching some steel parts in the tunnel

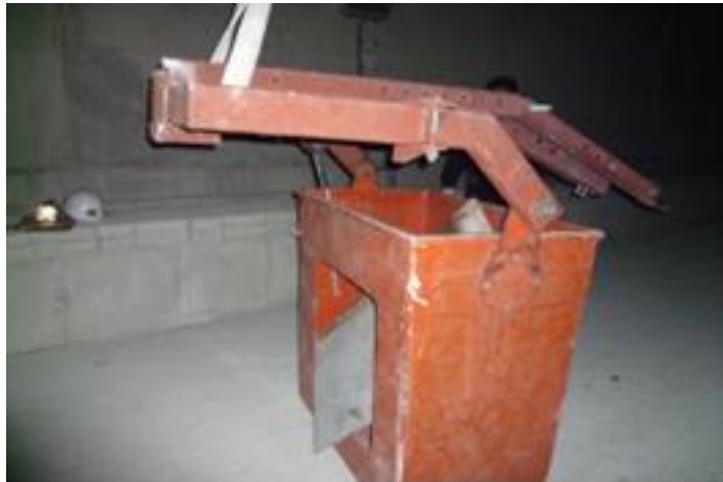
Figure 3: The bucket-type work platform fell down

platform fell down, the deformed shape of the lower part of the connecting end of the boom head and the bolts broken at the time of accident.

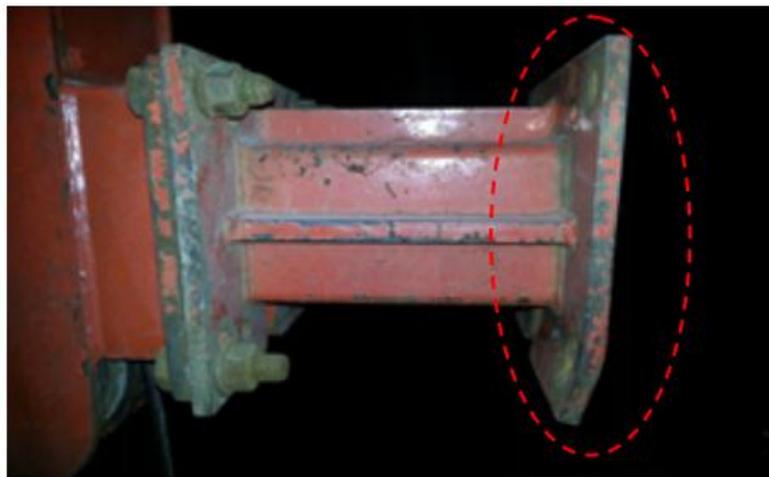
Figure 4: The deformed connecting end of the boom head

By referring to the above and the curved figure of the lower part of the connecting end of the boom head (refer to Figure 4), after the two upper bolts had been broken by the tensile force, the two lower bolts were supposed to be broken while sustaining the whole load applied at the time of the accident [5]. In addition, the X-deformation (U_x) along the Y-direction distance of the end plate of the bucket-type work platform to

Considering the maximum von Mises stress of the lower bolts obtained from FEA was 5,477 N/mm² and the minimum tensile strength of 900 N/mm² of the M16 bolt (strength classification 9.8), it was confirmed that when the upper fastening bolts were failed, the lower fastening bolts only could not withstand the loads applied at the time of the accident. Also, it was identified that the deformed shape of the connecting end of the boom head shown in FEA was very similar to the actual one (see Figs. 4 and 12).

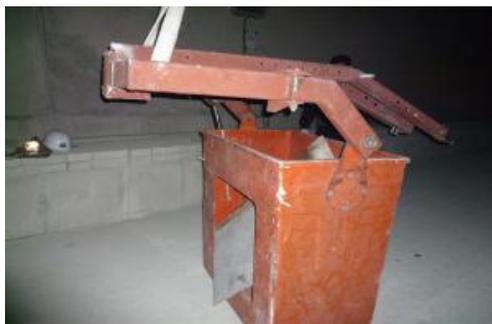
Figure 6: The modeling of the bucket-type work platform

Based on the above-mentioned investigations of the accident site, the bucket-type work platform excluding the bucket was modeled and the total weight of the sum of the weights (150 kg) of the bucket only and the steel parts in the bucket and the weight (140 kg) of two worker in the bucket was applied to the connection position where the bucket was connected as the external load. The modulus of elasticity of 200 GPa, Poisson's ratio of 0.3, bulk modulus 166.67 GPa and shear modulus 76.92 GPa provided by the manufacturer were applied on the bucket-type work platform.

(a) Bucket-type work platform

(b) XY view

(c) YZ view

(d) XYZ view
