Corrosion Behavior Studies of Al7075 Reinforced with Multiwalled Carbon Nanotubes Metal Matrix Composites in Acidic Medium

Abstract

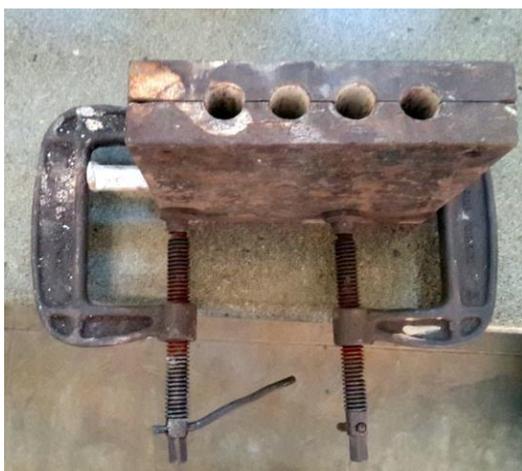
Figure 1: The Die set after Pre Heating

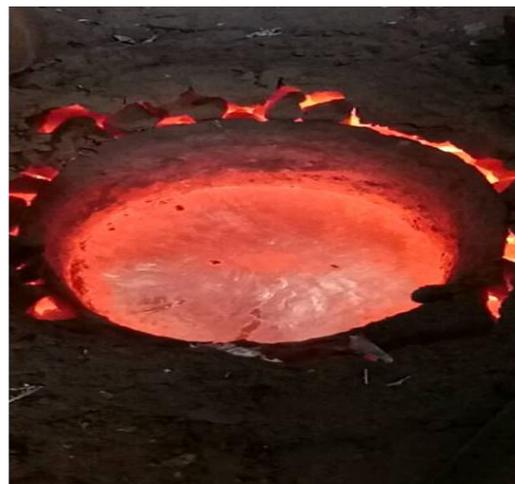
Figure 2: Al7075 alloy Melt at desired Temperature

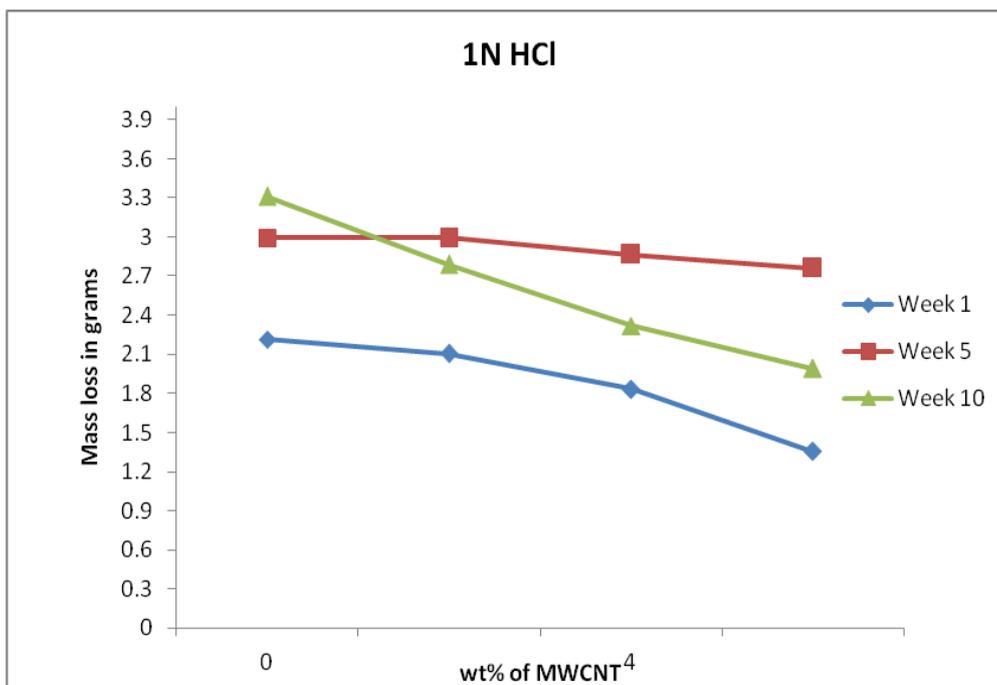
Figure 3: Mass loss vs wt% of MWCNTs for 1N HCl

The average values of the corrosion loss for the week 1, week 5 and week 10 is depicted in the Fig 3, Fig 4 and Fig 5 , the corrosion loss tends to increase as and when the duration of exposure increased. But with the increase in the wt% of MWCNTs the corrosion loss was diminished table 3,4,5 gives the data regarding the corrosion loss. The addition of more

MWCNTs increases the corrosion resistance of the composites. The strong intermetallic bonding must be the reason to the improved resistance to corrosion whereas in the unreinforced alloy the hydrogen reacts with the anions and loss is more. The corrosion loss will be even more reduced if the more percentage of Ni coating is deposited over the MWCNTs which enhances the interfacial bonding.

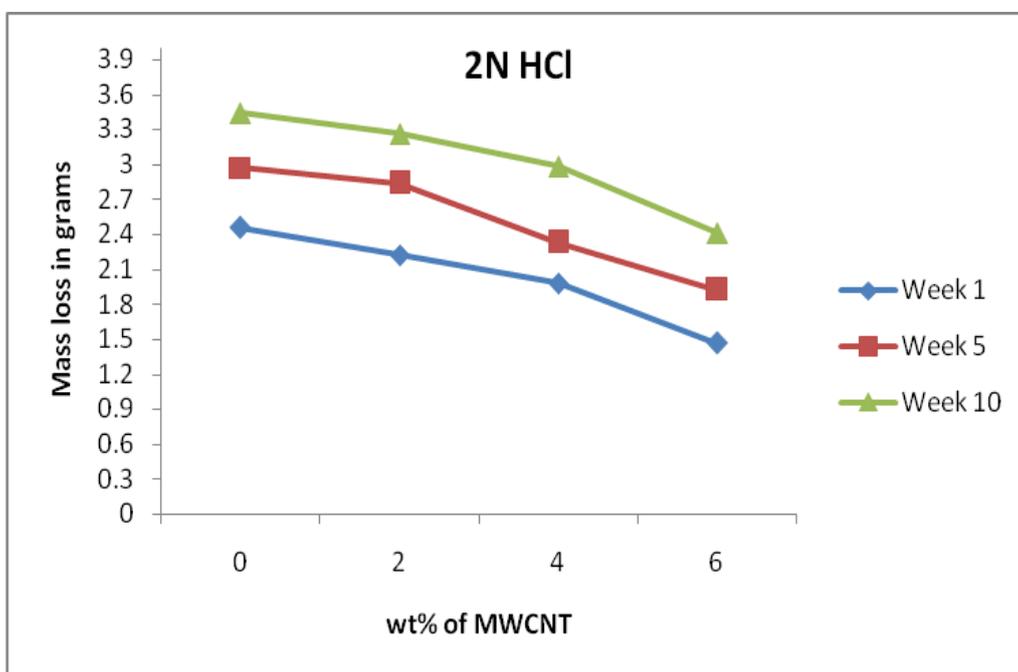
Figure 4: Mass loss vs wt% of MWCNTs for 2N HCl

The increase in the corrosion rate was also observed along with the increased Normality Fig 4, Fig 5. This is because the more acidic nature favors the deterioration of the material this influence can be retarded by the addition of the MWCNTs for 6wt% the trend was decrease in the Corrosion rate Fig 5. The MWCNTs plays a significant role in reducing the Corrosion.

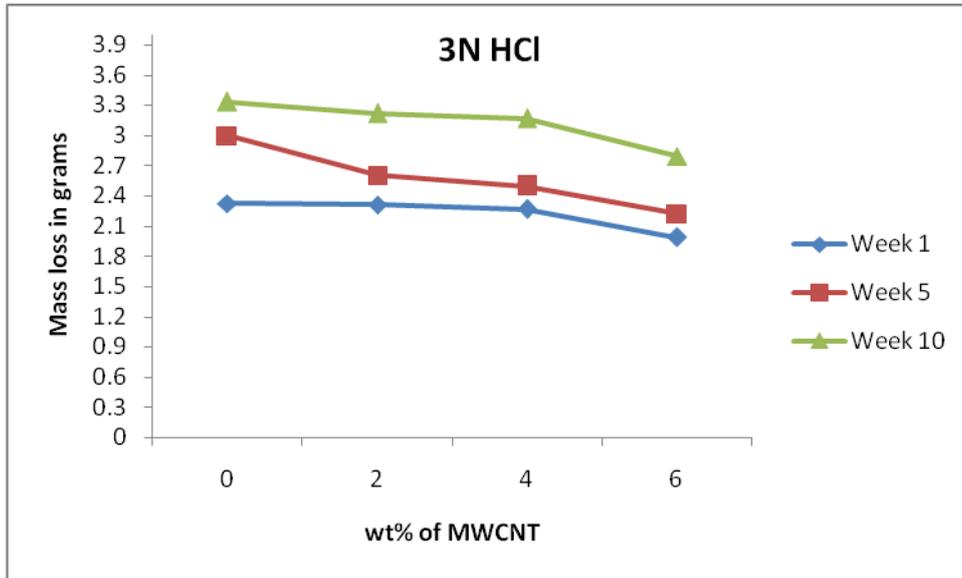
Figure 5: Mass loss vs wt% of MWCNTs for 2N HCl

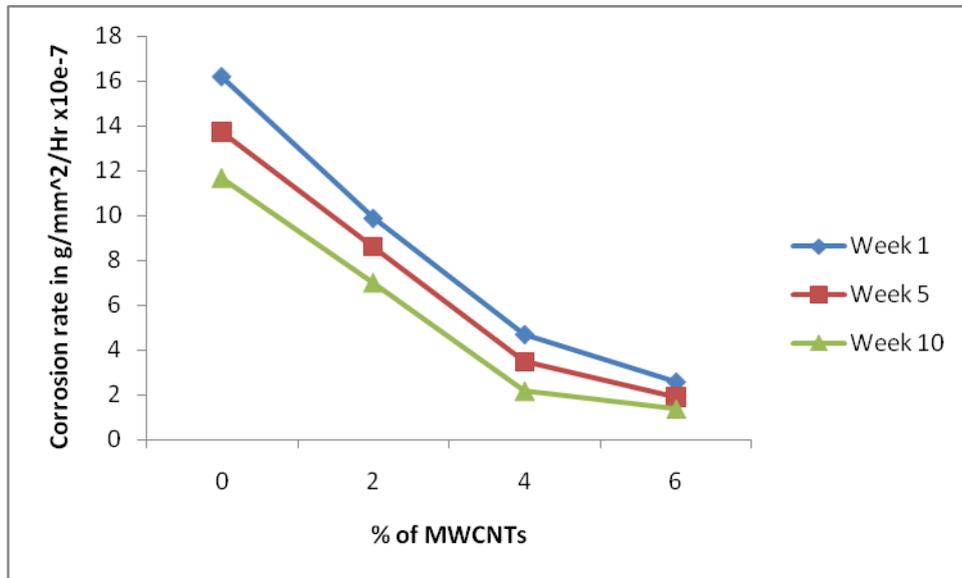
Fig. 6 shows the plot of Corrosion rate vs wt% of MWCNTs we can see clearly as the reinforcements increases the corrosion rates have been considerably decreased for the long duration.

Figure 6: Corrosion rate vs wt% of MWCNTs

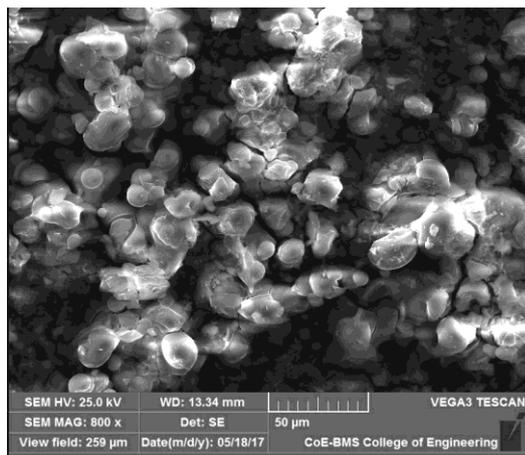
Figure 7: Unreinforced Al7075 before Corrosion Test

Fig. 7 shows the SEM image of the unreinforced Al7075 matrix before test which confirms the uniform distribution of the MWCNTs in the matrix. The Stir casting founds to be effective in the dispersion of the reinforcements. Fig. 8 shows the after corrosion test result for the duration of 10 weeks it is evident from then SEM image that the pitting has occurred along the grain boundary giving rise to white corrosive flakes in crystallographic orientations. The agglomerations of the MWCNTs in the Al matrix is still present this can be

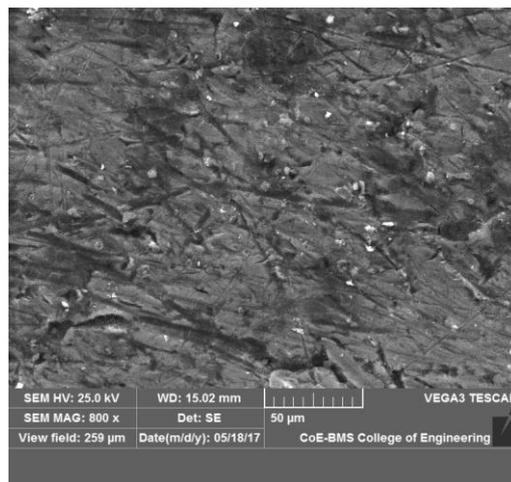
Figure 8: Unreinforced Al7075 after Corrosion Test

The micro cracks observed along the grain boundaries Fig. 8 shows the corroded in the 5th week duration this crack progression continues with in increase in normality of the HCl solution since the environment becomes more acidic. Tiny pits which is not visible through the visual inspection is observed by the SEM micrograph these pits are volcanic in shape Fig. 10 clearly depicts the degradation of the material with long exposure to the Corrodent and that too for increased normality. When compared to the wt% of the reinforcements the Pits was observed less in 6wt% of MWCNTs possibly due the increased corrosion that was achieved by the Composites.

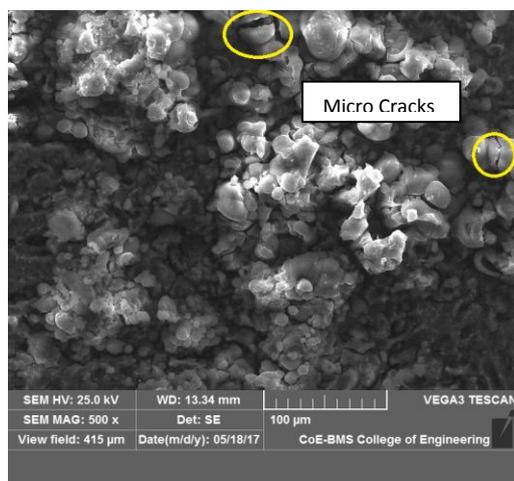
Figure 9: Corroded surface of the 6wt% MWCNTs in 5th week Corrosion Test

minimized by the precise stirring speed so that the uniform dispersion of the reinforcements takes place. The microstructure also supports the Stir casting technique is effective to prepare nanocomposites. The severity in corrosion was decreased as the percentage of MWCNTs was increased upto 6% but it was found for increasing duration for 5th week and 10th week as the duration increased the corrosion was also found increasing drastically Fig. 9 and Fig. 10.

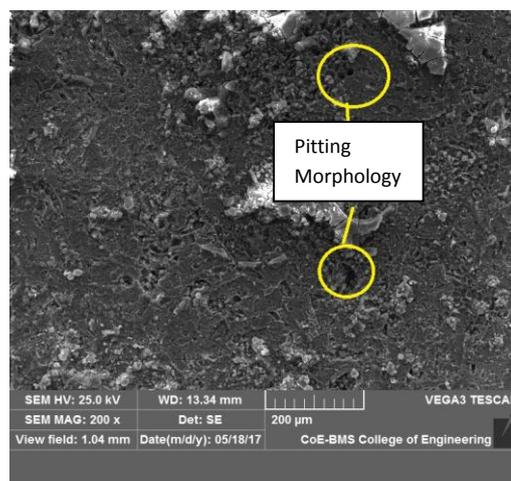
Figure 10: Corroded surface of the 6wt% MWCNTs in 10th week Corrosion Test
