Seismic Response of Vertically Irregular RC Frame with Stiffness Irregularity at Ground Floor

Abstract

Keywords: Structural Irregularities, Vertical irregularities, Stiffness irregularities, I.S 1893:2002(Part1) Provisions, Base Shear, Storey Drift.

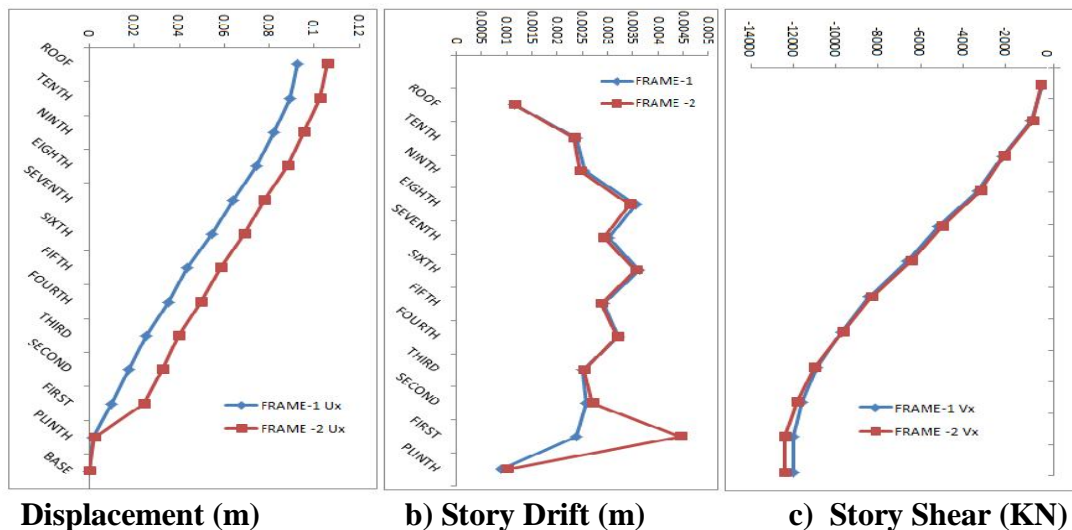
Figure 3: Response of various frames with irregularities.

on the vertically irregular frame. The results are presented and discussed hereafter. Table-3 shows displacement of storeys of various frames in X-direction (horizontal) graphically presented in figure

Storey-drifts for all the frames are tabulated Table-4 while graphically presented in Fig. 3(b). Frame-1 and frame-2 are seen to exhibit abrupt change in storey drifts at ground storey, which is slightly changed in respective storey.

The storey shears as given by ETABS using IS 1893 part-1: 2002, are tabulated in Table-5 and represented in Fig. 3(c). Frame-2, being the slightly heaviest one, develops considerable amount of shear force in its storey's compare to Frames 1.
