Atmospheric Corrosion of Stainless Steel 304

Abstract

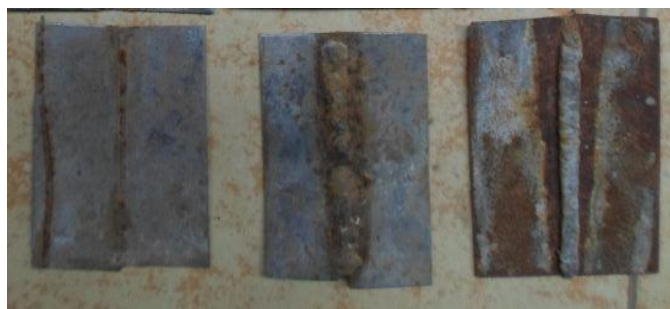
Fig 1 below shows the stainless steel specimens after outdoor exposure for a period of 30 days:

Fig 1: Exposed specimens of stainless steel

After 10 days of exposures, the amount of surface degradation on the samples was analyzed using the ImageJ software that supports standard image processing functions and image analysis.

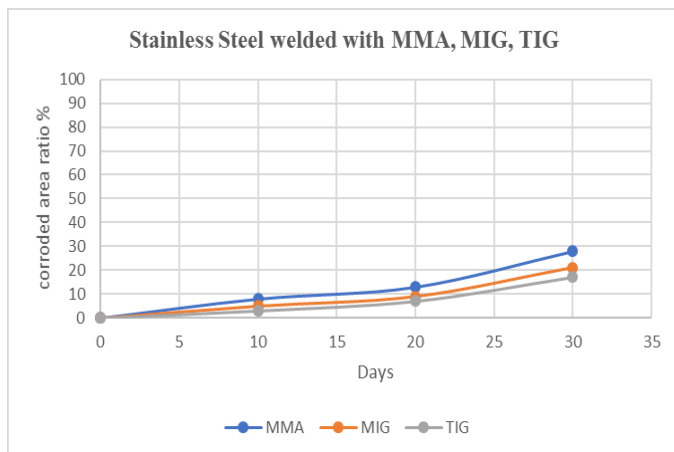
To compare the corroded area ratio of the weld metal, corroded area ratio against exposure time (days) for all the 3 specimens were plotted on the graph

Fig 4: Corroded area ratio against exposure time (days) for Stainless steel

Corroded area ratio of the stainless steel plates welded with MMA were greater than the rates experienced by MIG and TIG specimens, Average corroded area ratio per each surface on these plates extended to above 28% at 120 cycles, as compared to the less than 21% and 17% of average corroded area ratio experienced by MIG and TIG respectively. The corrosion loss data for these base plate configurations appear to be increasing with increased testing cycles.

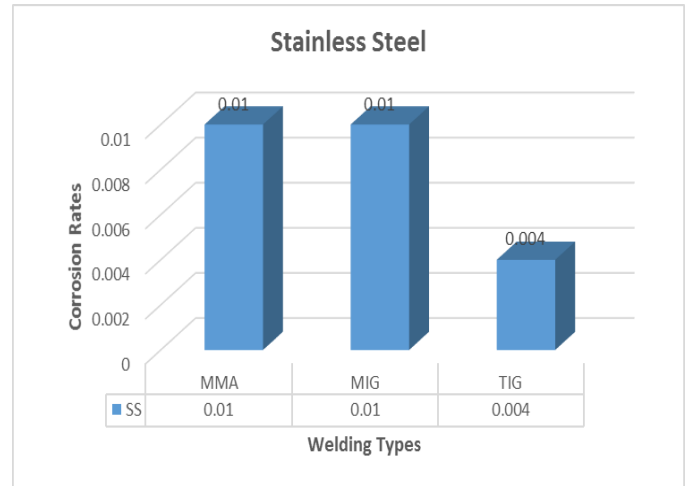
Fig 7: Corrosion rate of stainless steel welded using MMA, MIG, and TIG

The Corrosion rates after 120 cycles were similar for MMA, MIG equal to 0.01 mm/y, and 0.004 mm/y for TIG, giving an average of weight loss 0.12%; 0.09% and 0.03% respectively.

These results showed a general pattern of increase in percentage weight loss (PWL) and a corresponding increase in corrosion rate (CR) in the samples, with respect to time. An inverse proportional trend seems to exist between the weight loss and corrosion rate over time.

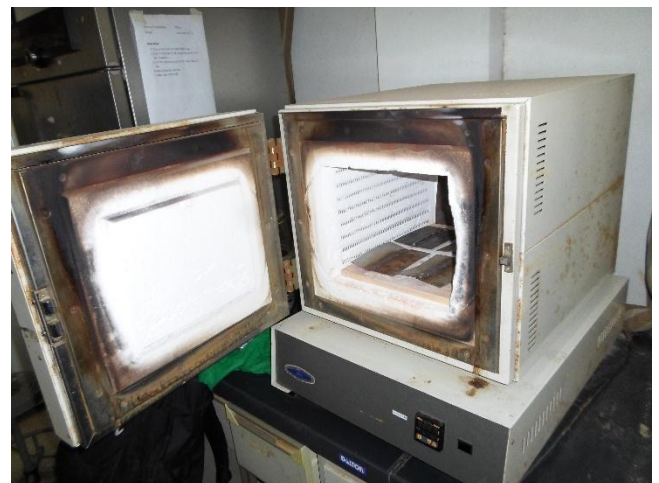
Fig 8: Heat Treatment of Stainless steel

The heat treatment was done to investigate the influence on the corrosion behavior of the material, The stainless steel is heated until 600°C temperature and then air-cooled. The normalized specimens have improved hardness, strength and machinability. This heat treatment is more extensively used since it is more economical.

Corrosion rates of the specimens showed decreasing trend before it remained consistent throughout. The rate of corrosion for all specimens was low because of the change in the physical properties of the metal. Normalized stainless steels are harder and stronger than normal stainless steel that explain their corrosion resistance.
